INVESTIGATION OF THE A-7 HOOK POINT
ATTACHMENT BOLT LOOSENING PROBLEM

THESIS

December 1974

MASTER OF SCIENCE IN AERONAUTICAL ENGINEERING

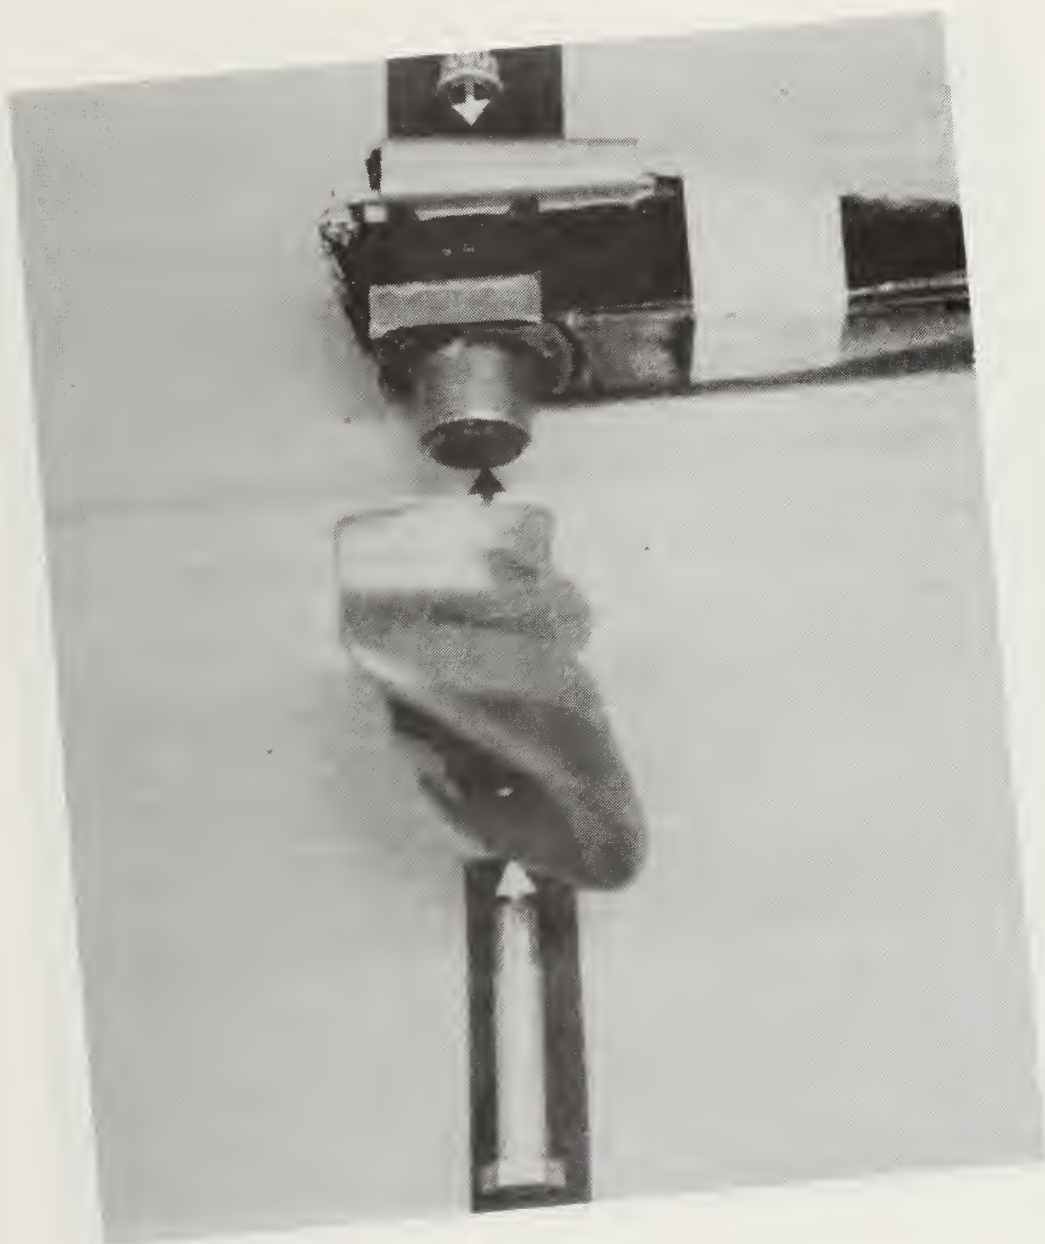
Figure 2. Exploded view of hook point-boss joint.

Looking at the way the hook point attachment assembly is put together, Fig. 2, and how the bolt head is securely held in the hook point, Fig. 4, it can be seen that any sliding of the hook point relative to its seat on the shank results in transverse loading which Junker (Ref. 24) points out is the severest condition for the occurrence of self loosening. It was decided, based on the above, to investigate the possibility that large magnitude, low cycle, and low frequency hook loading of an arrested landing could cause the attachment bolt-nut combination to self loosen.

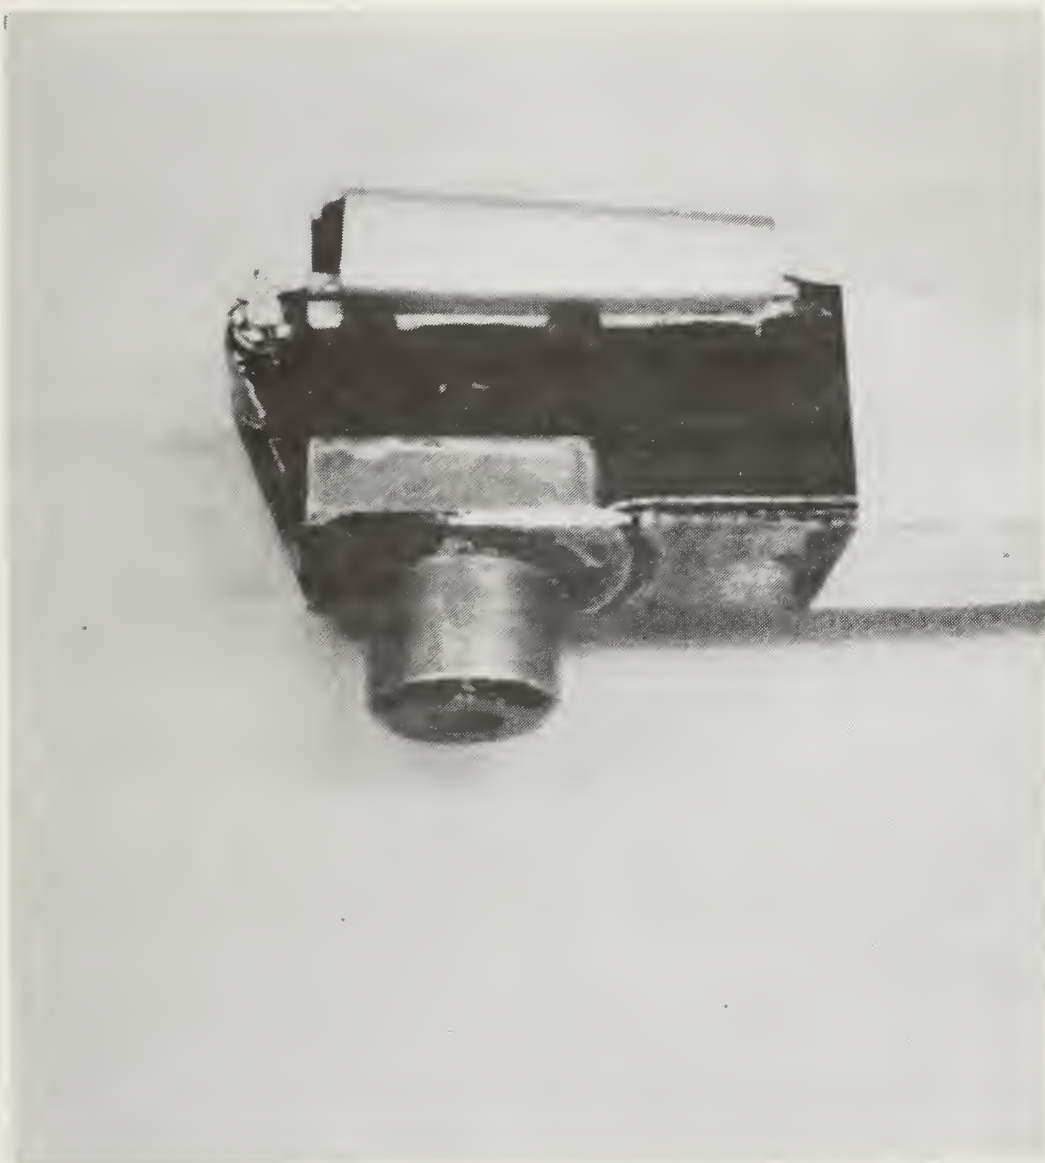
Figure 6. Side view of hook shank boss.

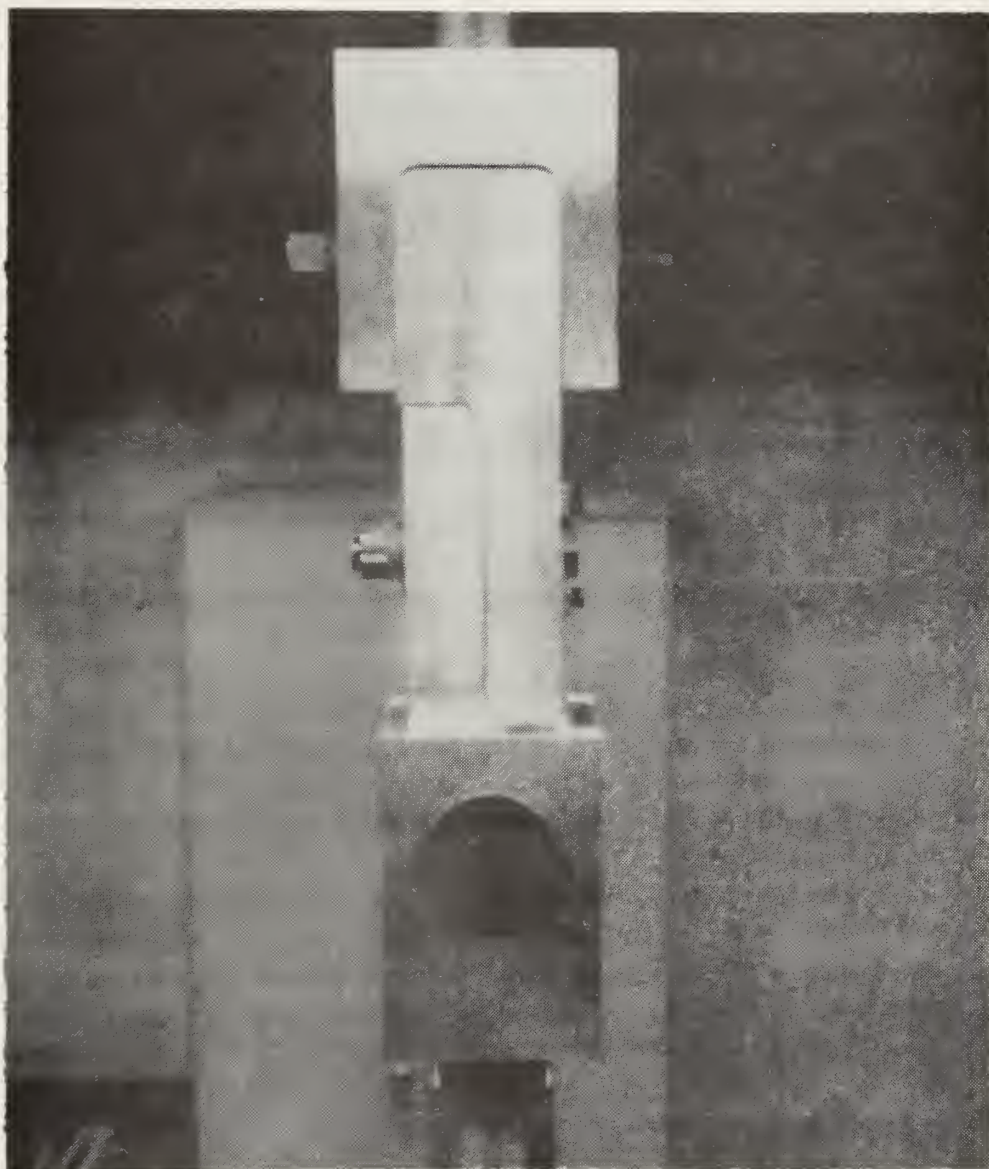
Figure 20. The test fixture.

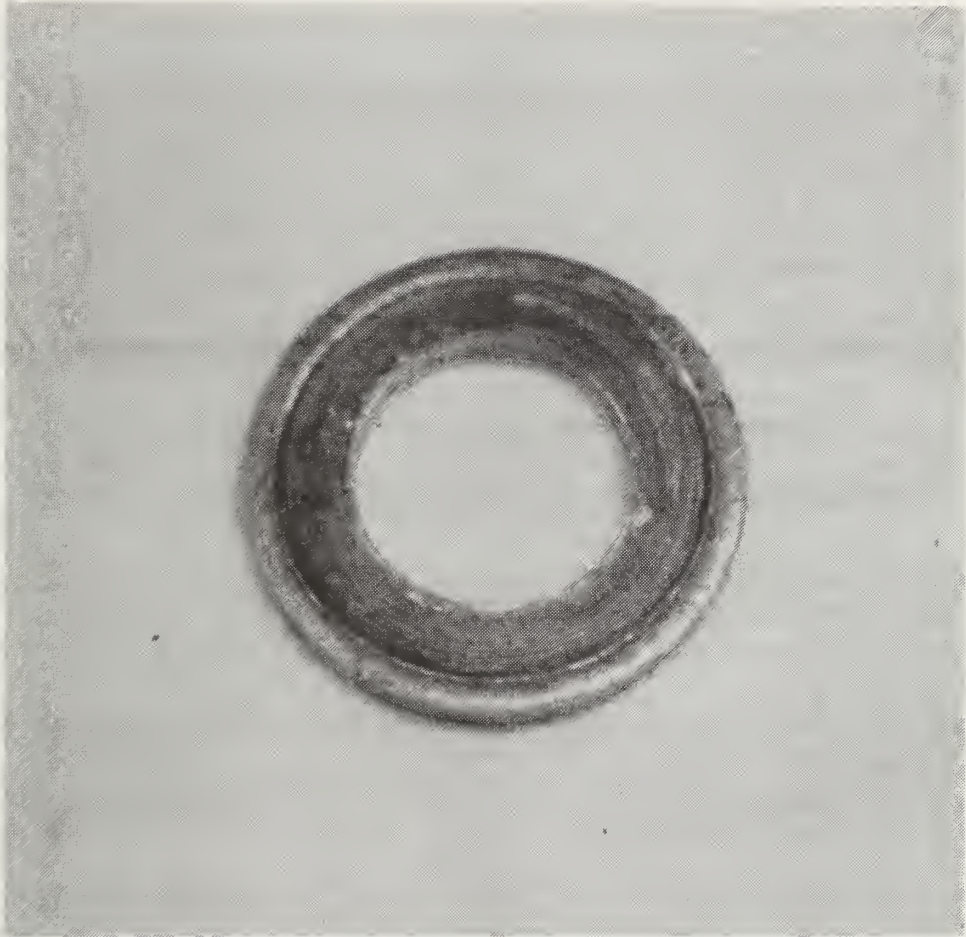
Figure 22. Crushed washer from first three tests in Series "C".

b. only high-strength (hardened) steel washers be used in the hook retaining assembly.

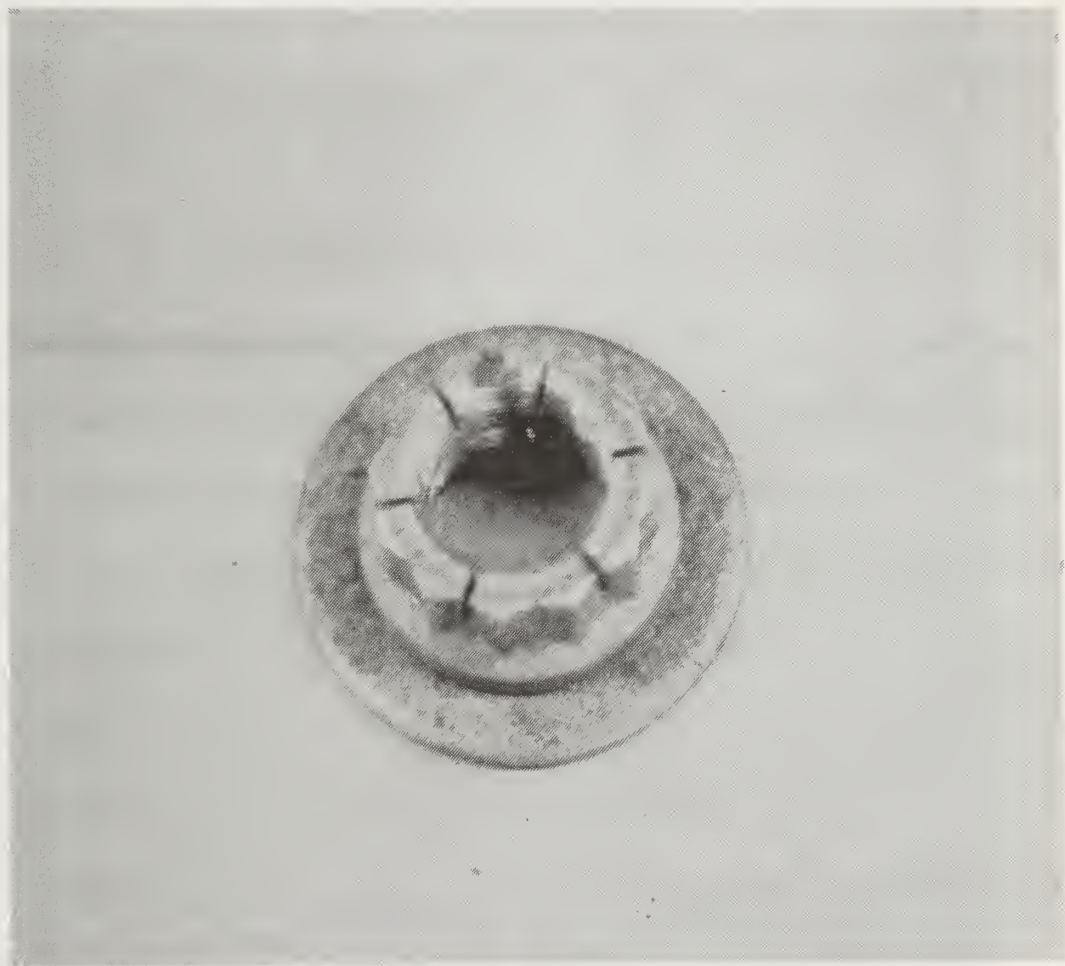
Figure 23. Nut seated in the crushed part of the washer.

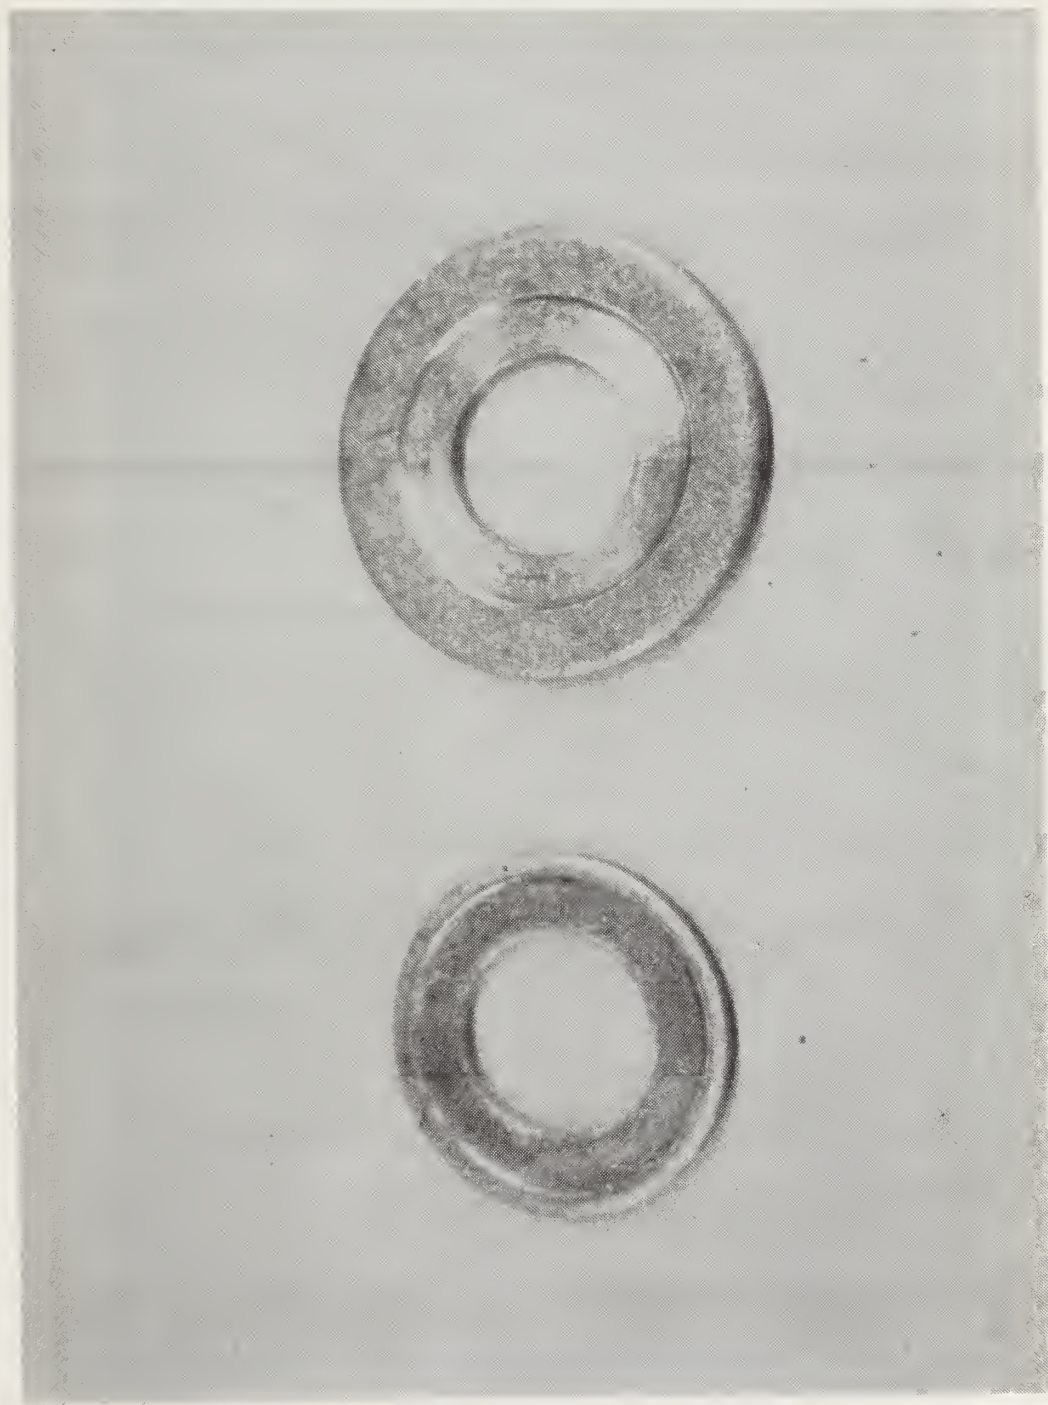
Figure 24. The two crushed washers in Series "C".
